BY MARIANNE SCOTT

DISMASTED!

From the initial crisis to the expensive aftermath, hear the exciting tale of **LOSING A RIG** in Puget Sound

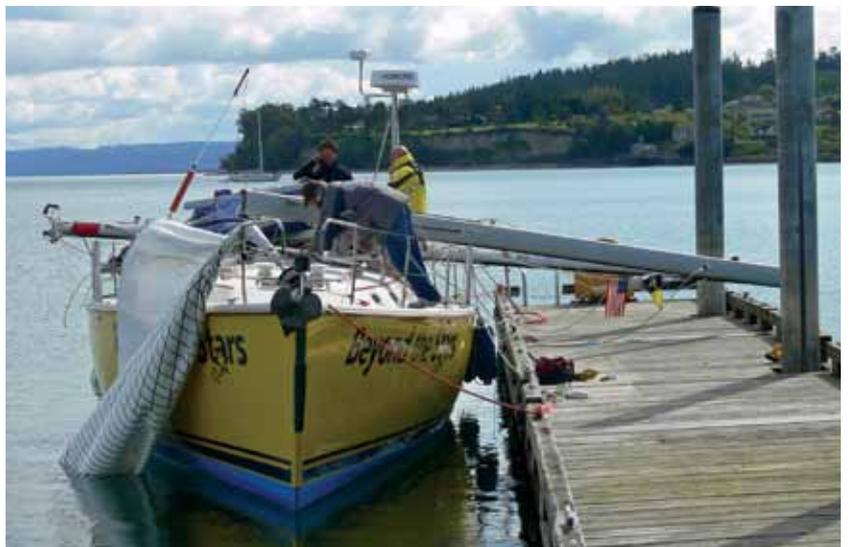
↑ **Above Top** The top portion of the mast jammed the steering wheel and had to be winched free before they could steer. ↑ **Above Beyond the Stars** before being derigged at the dock at Coupeville.

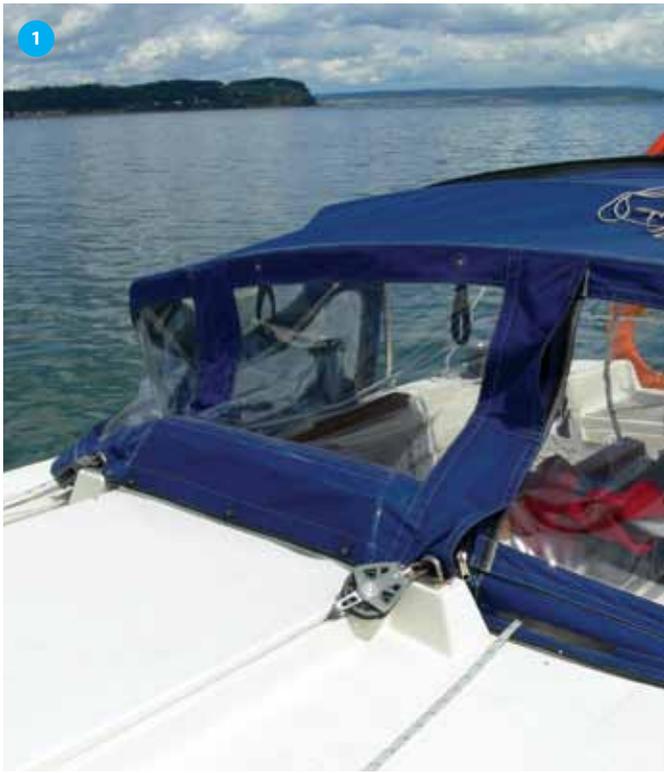
[1] The dodger leans heavily to starboard after supporting the weight of the mast.

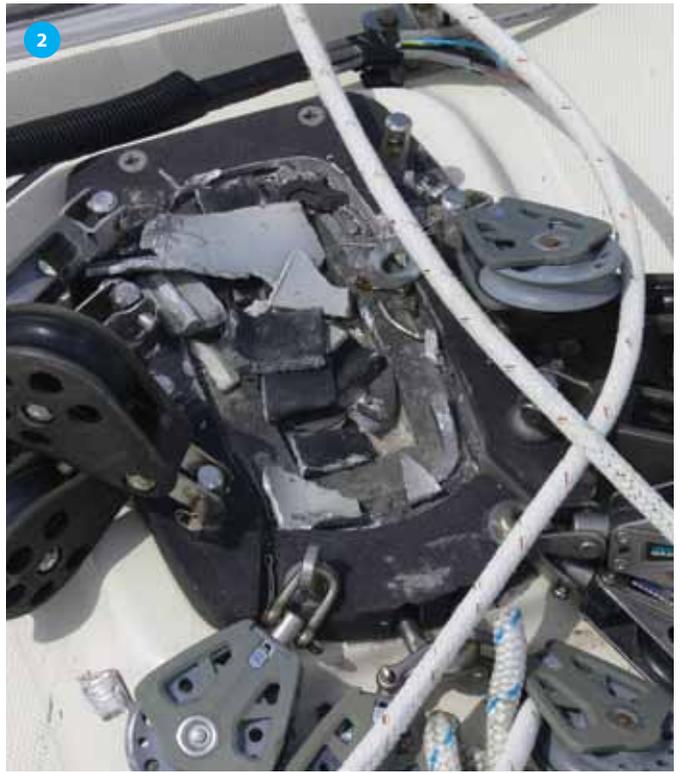
[2] The mast collar was broken and blocks chafed and crushed.

It’s amazing how many items become “throwaways” after an accident. The new wind transducer could no longer communicate with the existing wind instrument so it had to be replaced. Repairing the deep gouges on the anodized boom and jib traveler would be more costly than replacing them. Chafe had ruined blocks.

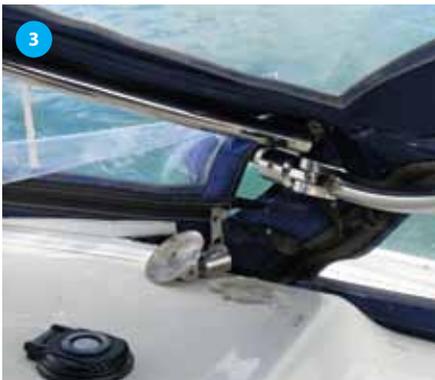
[3] The stainless dodger mount was ripped out of the fiberglass.

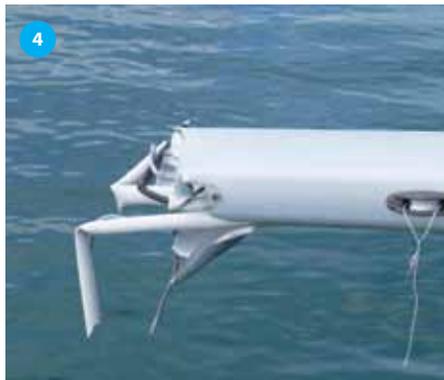
■ **WHAT HAPPENED** We believe our mast "pumped" fore and aft in the square waves. A combination of wind and waves creates a "frequency response" in the mast as it vibrates and oscillates. When the mast whips back and forth enough times, metal stress can cause it to fail. Why did this happen to a five-

[4] The shredded failure point.

year-old mast? *Beyond the Stars* carries a standard modern rig: double swept-back spreaders and no forward lower shrouds. In addition, our boat has a self-tacking jib with the jib sheet's sheave exiting the mast between the upper and lower spreaders, which could have been a focus point for the stress. The mast's aluminum literally shredded.

Allan Betton, of Total Boat Marine Surveyors (who helped us through the process with the insurance company), explained that a mast usually fails through a combination of factors. "It's a domino effect," he said. "Modern rig designs are geared to racing and weight saving. In this case, the jib sheet exiting in the mast's middle may have pulled the mast's bottom forward, while the top part bent aft. Constant repetition will weaken the structure."

■ **WHAT WE LEARNED** To reduce the likelihood of a future mast failure, our new spar, which took about six weeks to arrive from Sparcraft in North Carolina, is stepped with

more “prebend” to reduce pumping in square waves. To decrease rig stretching, the new shrouds are rod instead of wire. And we’re experimenting with our rigger, Brent Jacobi of Blackline Marine, on jib sheeting configurations that minimize the chances of weakening the mast’s structural integrity.
