BY MARIANNE SCOTT

DISMASTED!

From the initial crisis to the expensive aftermath, hear the exciting tale of **LOSING A RIG** in Puget Sound

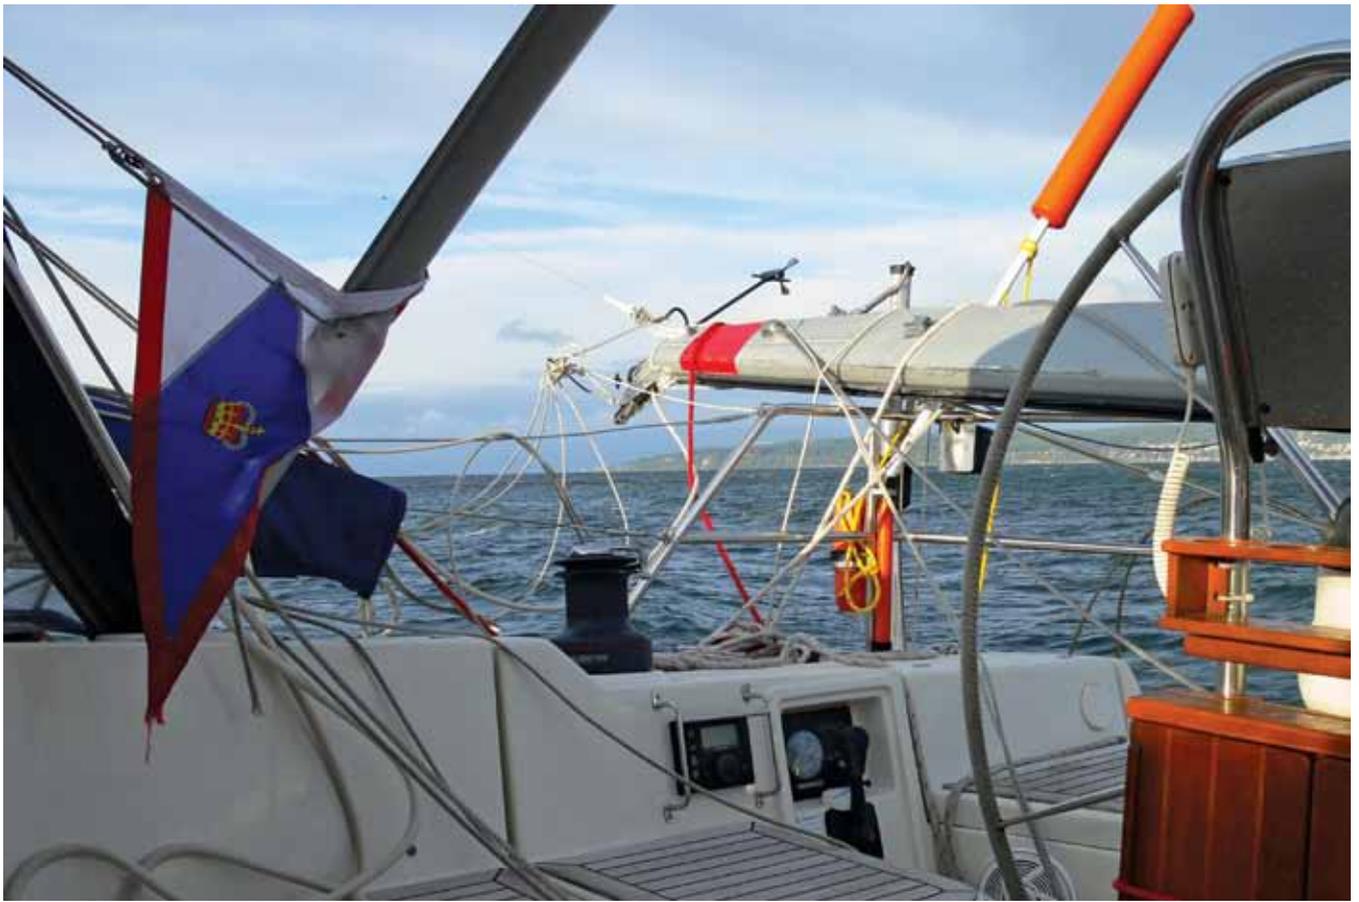
↑ **Above Top** The top portion of the mast jammed the steering wheel and had to be winched free before they could steer. ↑ **Above Beyond the Stars** before being derigged at the dock at Coupeville.
